Correction to

Printed-Circuit Board for the FT-817 Panadapter

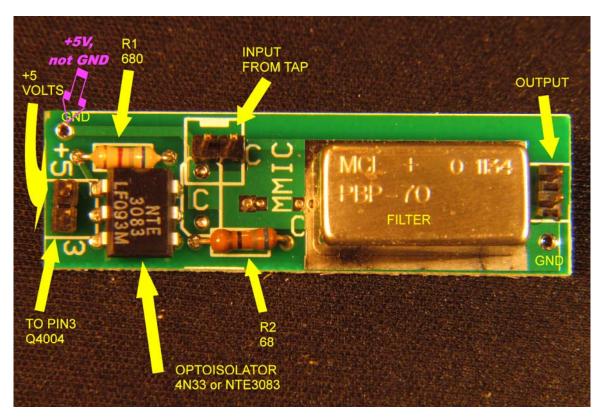
There was an error in the PC board connections shown in Figure 2. The hole in the upper left, marked GND in Figure 2, is actually connected to +5 volts. If you don't connect anything to the hole, it won't matter. GND connections are available at the input and output, and most of the filter pins.
